Overall View

Current Ceiling Material

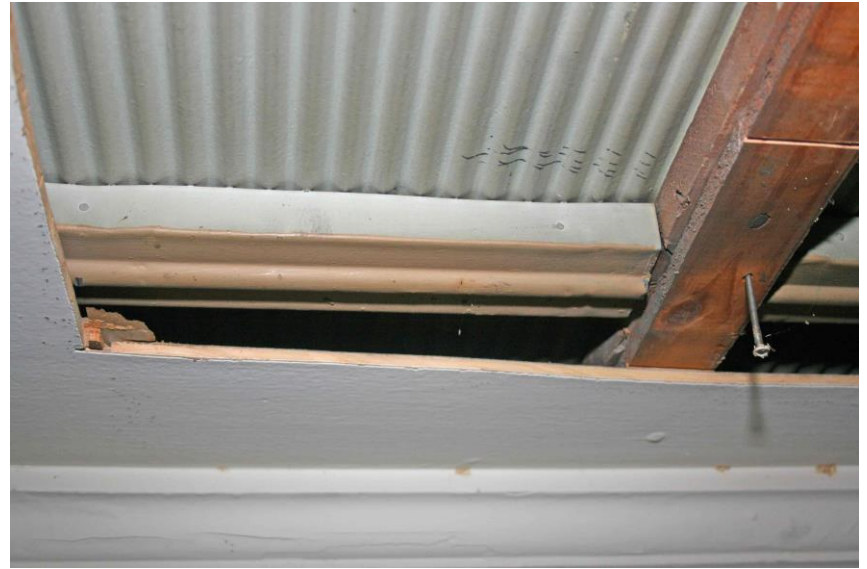
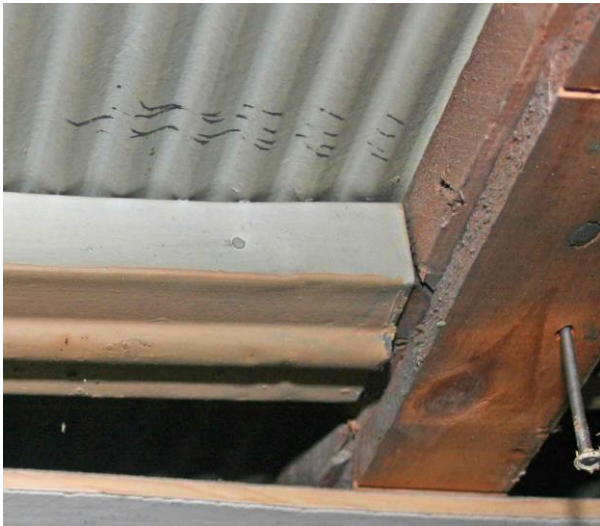
Painted Tin Ceiling

At some time the ceiling was covered with a corrugated tin material that was painted gray as shown in the photo at the right.

This ceiling was supported by wooden furring strips that were then covered by metal trim. The sides of the metal trim were painted gray to match the ceiling color, and the bottom of the metal trim was painted a light brown/tan color.

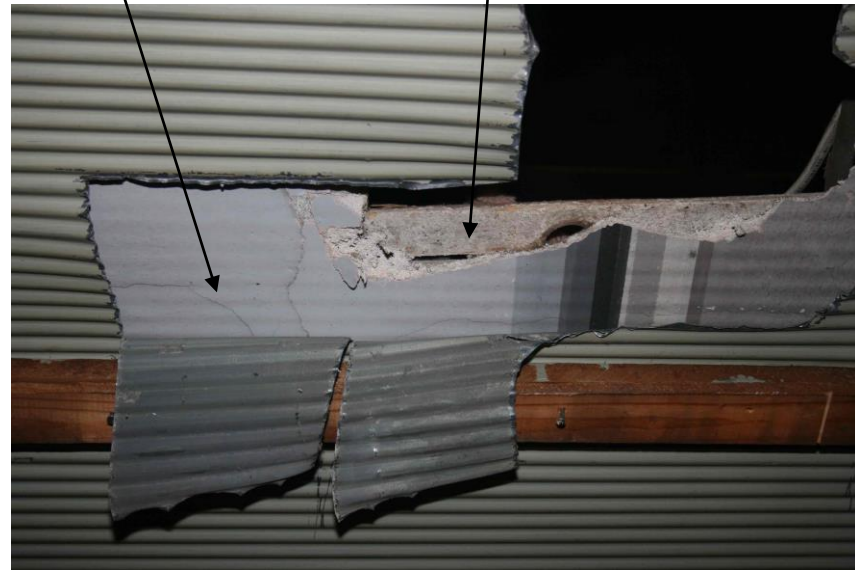
Original Plaster Ceiling

The picture to the right shows what might be the original plaster ceiling. The plaster is applied to lath strips running East/West in the ceiling.

Lath Strips

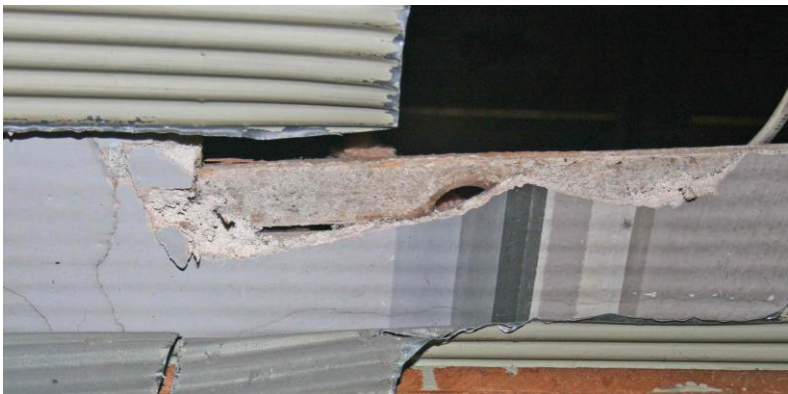
The picture on the left expands the above view and reveals a long-hidden detail painted into the original ceiling. The extent of this painted detail is unknown at this time.
